Decommissioning of BSS South Superior Tailings Dam

Description: Terratek carried out in 2020 numerical finite element model to analyse the behaviour of the BSS dam, built by the upstream method and found to present a low factor of safety against static liquefaction. The numerical model using Plaxis employed a UDSM (user-defined soil model) developed by Terratek using the NorSand constitutive model. Therefore, the model is aimed at modelling the tailings behaviour of post-peak loss of strength, or strain-softening

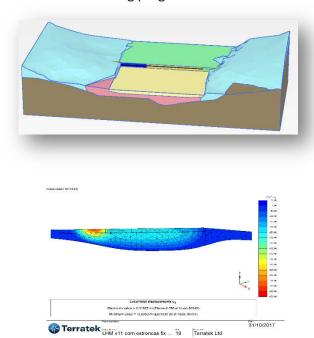
Design of sheet piling tailings dams

Description: Fundão dam failure in 2015 led the tailings to flow and pollute the Doce River. Vale and BHP Mining, owners of Fundão Dam, created the Renova Foundation to design and implement mitigation solutions for the disaster. One of them being three sheet piling dams across Doce River, to contain the tailings and enable dredging. Terratek was hired for a detailed Plaxis 3D analysis of the preliminary design and a monitoring programme with IPI's (in-place inclinometers). Plaxis 3D analysis showed a flaw in the preliminary design which would leed to large horizontal deformation on the sheet piling close to the right abutment and led to a thorough design review.

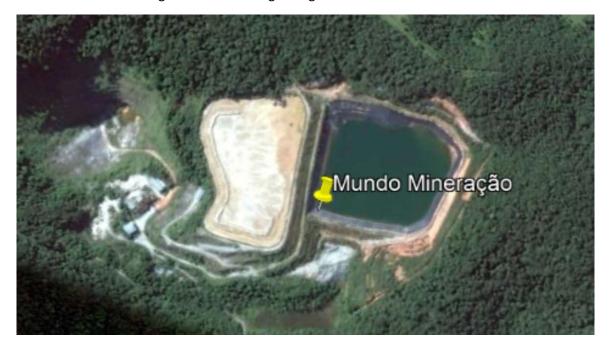
Decommissioning of Mundo Mining Co Tailings Dams.

Description: Terratek carried out in 2017 and 2018 the decommissioning design for the abandoned gold mine. One tailings dam and the other is an arsenic-contaminated reservoir. These dams are located 2 km upstream of the water intake structure for the City of Belo Horizonte, and their failure would result in an enormous environmental disaster.

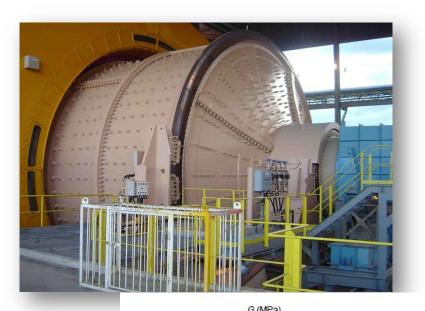
Project name: SAG Mill Foundation

Description: Back in 2007, RPM
Mining, now Kinross Mining, carried out
a large expansion project and the
deployment of a new SAG SemiAutogenous Grinding mill, 18 m in
diameter

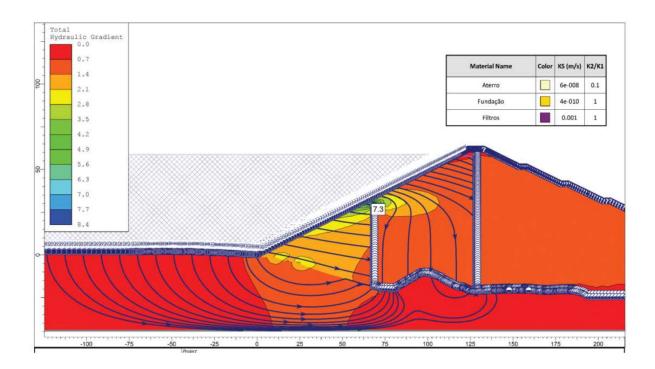
Design review of Maravilhas III Tailings Dam

Description: This is a tailings dam built by the downstream method and owned by Vale Mining. Construcap hired Terratek for the design review involving site visit and seepage, deformation and stability analyses. This work showed the need to redesign the rip-rap and high seepage gradients close to the top of the sand filter. Our recommendations also included improvement for the instrumentation programme.

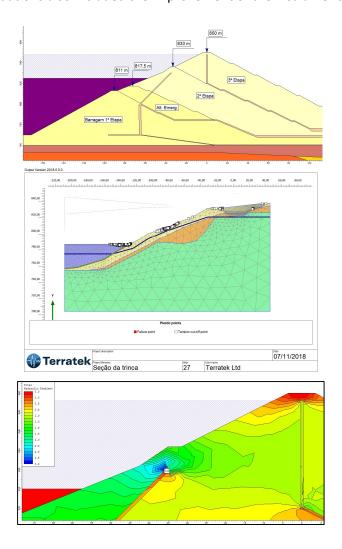
Itabiruçu Tailings Dam Design Review

Description: This is a tailings dam built by the downstream method and owned by Vale. Empa was awarded the contract to carry out the second lift and hired Terratek for the design review. The work included a site visit when the Terratek team observed a cross and another longitudinal crack through the compacted embankment dam. Terratek carried out document review and seepage, deformation and stability analyses. The deformation analysis showed tensile stress zones where the observed cracks took place This work showed high seepage gradients close to the top of the sand filter. Our recommendations also included the improvement of the instrumentation programme.

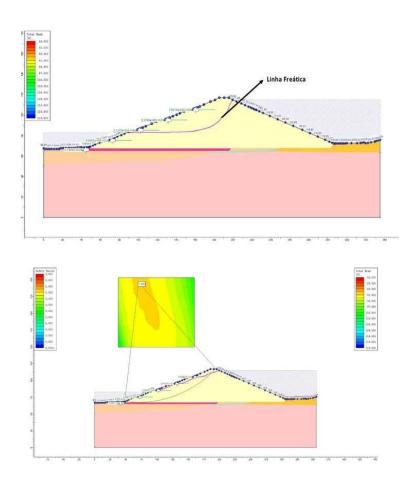
Sabão 1 & 2 Dams

Description: These are water reservoir dams belonging to Norsk Yara Fertilizers Mining. Construcap is the contractor and hired Terratek for the design review. The work included a site visit, document review and seepage and stability analyses. Our analyses showed that the seepage analyses carried out by the designer was wrong due to the conceptual mistaken selection of compacted clay permeabilities, taken equally in the vertical and horizontal direction. This misconception led to recommendations to change the dams drainage system to avoid the phreatic water level crossing the downstream slope of the dams.

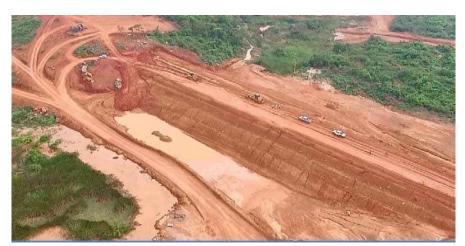
Avanco Dam Design & Construction Method Review

Description: Avanco Copper Mining in the Amazon built during 2015 – 2016 a tailings dam, 11 m high, 320 m long embankment dam using the downstream lifting method. The drainage system consists of a horizontal sand blanket filter connected to the vertical chimney filter

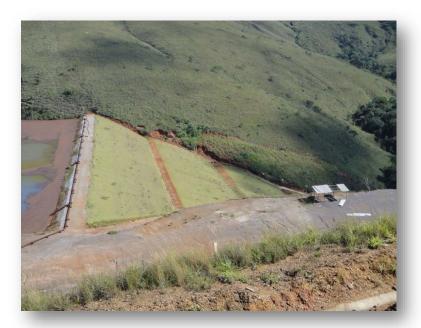
Alemães Tailings Dam

Description: This earth structure is a tailings dam constructed by the downstream method. The starting dam is 50 m high, 180 m long embankment founded on phyllite rock.

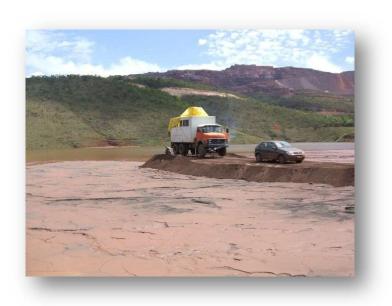
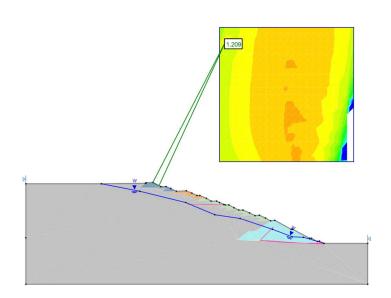
Itatiaiuçu Tailings Dam Review

Description: In 2009 Terratek was hired to investigate the stability of the tailings dam, about 100 m high and built by the upstream construction method. The work involved site investigation including in situ and lab testing and analyses. This work showed loose silty sandy tailings and a very high water level in the dam, close to the dam slope. Undrained laboratory testing showed liquefiable tailings with a cohesionless behaviour and a drained friction angle of 26 degrees. Stability analyses yielded a very low factor of safety FS = 1.25. Terratek's final report did not ensure dam stability.

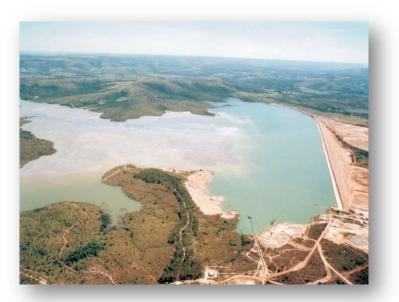
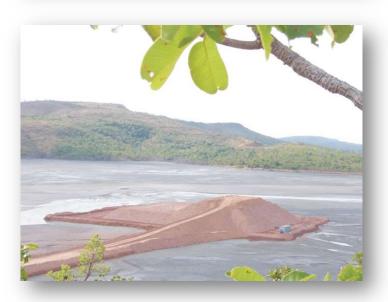
Project name: Morro do Ouro Tailings Dam

Description: Morro do Ouro tailings dam is 4 km long and 120 m high, is among the world's largest dams of its type. Terratek provided geotechnical services from 2002 to 2008. It involves the dam and other structures such as the SAG mill foundation, slope stability of the pit,

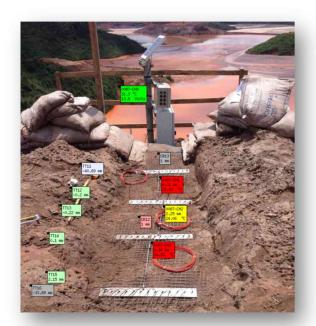
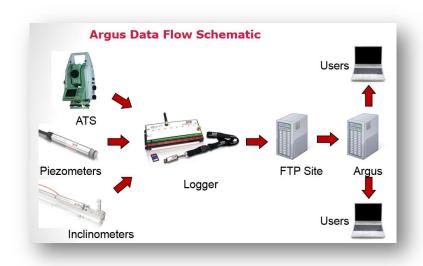
Project name: Germano Tailings Dam

Description: Germano tailings dam is 110 m high and, by the time of its completion in 2020 will be 140 m high. Terratek installed an automated monitoring system
